# Photocathode Behavior During High Current Running in the Cornell ERL Photoinjector

## Abstract

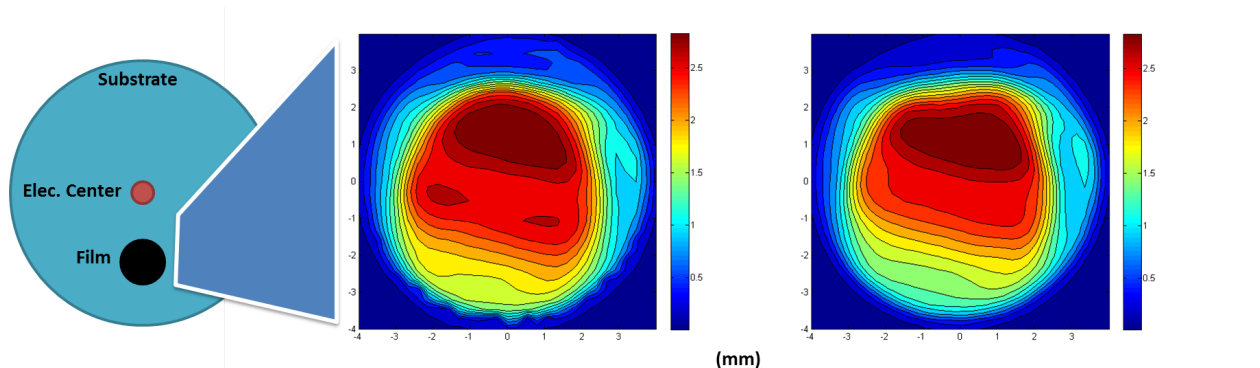
FIG. 1: A schematic of the photocathode substrate and film is shown at left. The QE (%) map of the photocathode is shown before running (middle) and after (right).

One of the samples, having a diameter of about 8 mm, was grown approximately 6 mm off-center with respect to the puck symmetry axis, done in anticipation of the damage to the electrostatic center. After the growth, the puck and photocathode were transferred by means of a dedicated UHV suitcase to the load lock chamber of the ERL prototype DC gun [5]. The QE map of the photocathode was measured with a small DC laser at 532 nm once in the load lock chamber, and before insertion into the gun, and is shown in Fig. (1).

The QE peak (3%) as well as the QE uniformity were deemed non-ideal, likely due to misalignment of the evaporating sources within the deposition chamber. The poor uniformity was verified with XRF measurements performed at the F3 line at the Cornell High Energy Synchrotron Source (CHESS). The F3 station used a 10 keV X-ray beam with approximately 10  $\mu\text{m}$  diameter, incident upon the sample surface with a coincidence angle of 45 degrees. An energy dispersive Vortex ME4 silicon drift detector fabricated by SII Nanotechnology measured X-ray fluorescence from the sample, which is generally capable detecting trace elements down to the parts per million level. The sample was scanned with the use of a 2D translation stage, yielding 2D maps of the atomic areal density, and thus ultimately the chemical composition. In order to calibrate the fluorescent flux incident on the detector to yield the atomic areal density, we prepared thin film test samples on Si substrates for Sb, K, and Cs. Rutherford backscattering measurements were then used to determine the areal density of the thin film test samples, and these test samples were then run under XRF prior to analyzing the actual photocathode sample. The XRF maps are plotted in Fig. (2). Several causes contribute to a large systematic uncertainty is inherent in these measurements. First, the RBS beam scatters off a small area of the substrate, and the test films analyzed for calibration also include the large variations in surface concentration. Second, these measurements were performed in air after the cathode's use in the injector, and it is unknown how interaction with air will affect the areal density of the film constituents. Finally, in the case of the potassium test film, it was seen that the potassium RBS scattering peak lies too close to that of Si to allow a precise determination of the areal density. Thus, the values quoted for potassium should be viewed only as lower bounds; it is possible that the stoichiometry is closer to the expected value of  $\text{K}_2\text{CsSb}$ .

After an approximate run time of 8 hours, and a total charge delivered of about 575 Coulombs, the photocathode puck was retracted into the UHV preparation chamber for visual inspection and QE measurement. It should be noted that the QE, as determined by the delivered laser power (data not available), showed no apparent degradation and did not limit the length of the run; the run ended at the preference of the operators. The post-run QE map in Fig.(1, right) shows a small, nonuniform decrease, with more significant damage toward the gun electrostatic center, which in the above maps is upward.

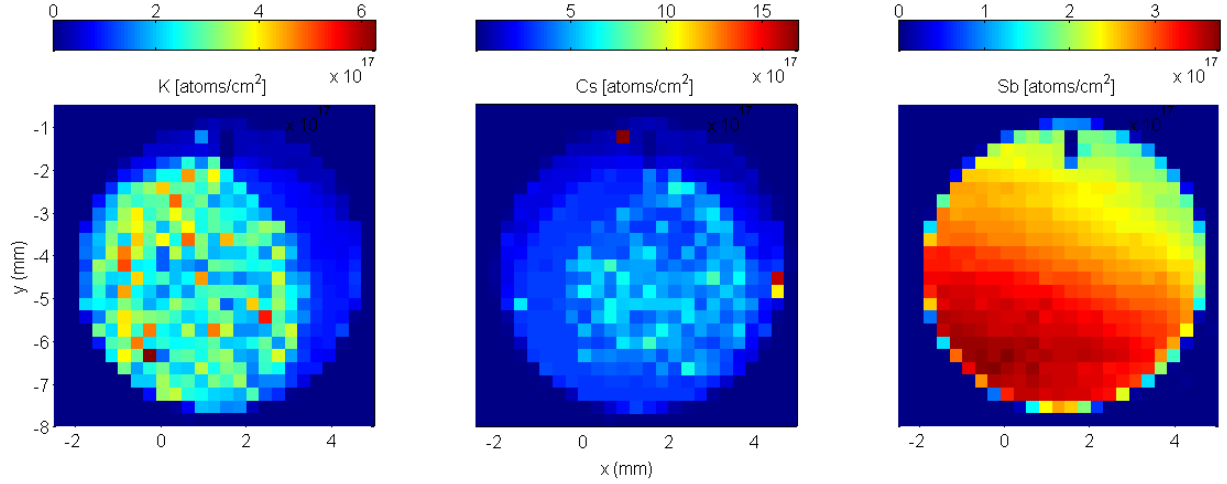
FIG. 2: XRF maps for K (left), Cs (middle), and Sb (right). A notch had been scribed in the sample for orientation purposes. The stoichiometry, normalized to the Sb areal density, averaged over the active area was found to be  $K_{0.8}Cs_{1.29}Sb$ , where the values for the potassium areal density should be treated as a lower bound on the actual value (see text).

The atomic areal density maps clearly show a non-uniform distribution of the metallic species, implying some misalignment of the substrate with the evaporative sources, and thereby creating a nonuniform QE distribution. Nevertheless, this photocathode had sufficiently high QE to be operated as a first test for delivering mA level current, and to investigate its ruggedness with respect to long operation times. It is interesting to note that though clearly visible to the naked eye (see below), the features of damage from use are not evident in the XRF maps.

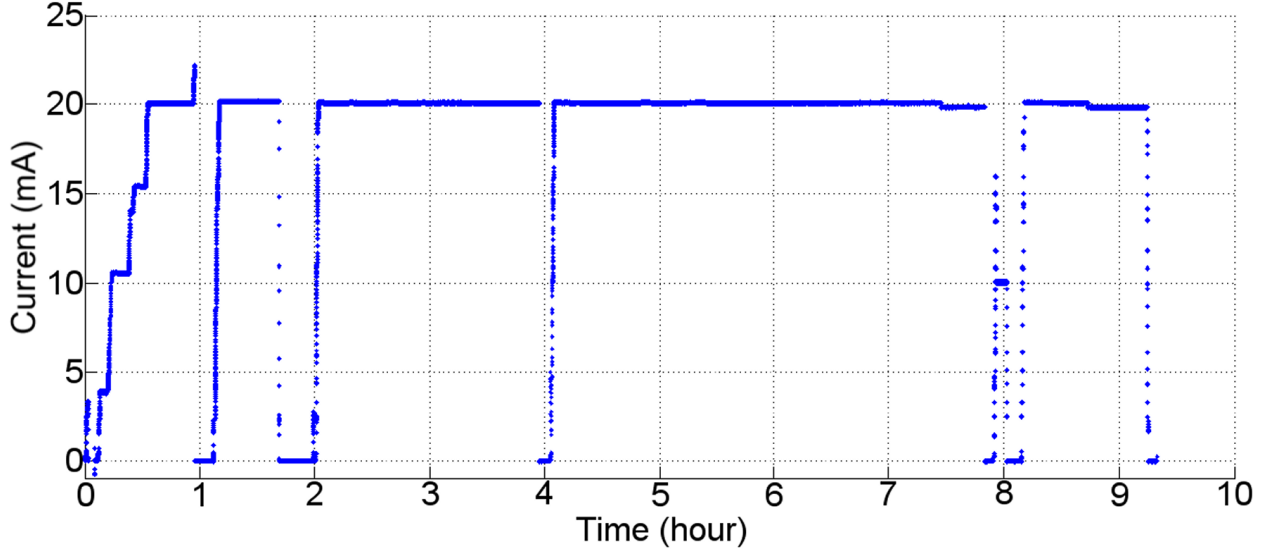
FIG. 4: Current as a function of time for the run in question.

varies the laser power on the cathode via a Pockels cell, to account for variations in upstream laser power, as well as gradual degradation of cathode quantum efficiency. As visible in Fig. (4), during injector operation, a number of vacuum burst events triggered the fast shutdown safety system. After each trip, the beam current was successfully restored to 20 mA.

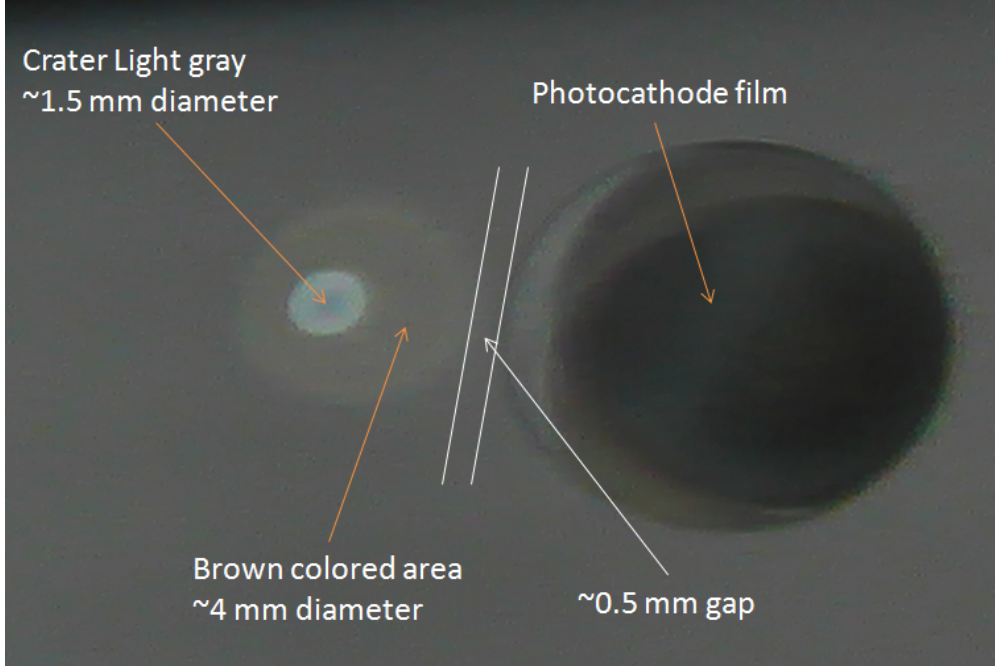
FIG. 5: A close-up photo of the photocathode film and substrate after use.

- *The Photocathode Film:* The three non-concentric rings of the bi-alkali film indicate the poor alignment of the substrate with the evaporative alkali sources. This, along with the XRF species maps, supports the hypothesis that the poor QE performance is due in part to poor alignment.
- *The Central Damage:* Located roughly at the electrostatic center of the puck, approximately 7 mm from the center of the photocathode film, this region has a well defined circular shape. Naked eye inspection suggests extreme surface roughening due to the loss of the typical mirror-finish of the polished Si substrate.
- *The Brownish Area:* This area asymmetrically surrounds the central damage area, and presents a brownish color and loss of mirror-finish. The centroid of this region is shifted towards the site of electron emission.

The most salient feature of the photocathode appearance upon removal from the gun was the presence of a highly damaged area approximately at the electrostatic center of the gun. A photograph taken in air of the sample after removal from the gun is found in Fig. (5). Naked eye inspection of the surface reveals different regions with well defined characteristics:

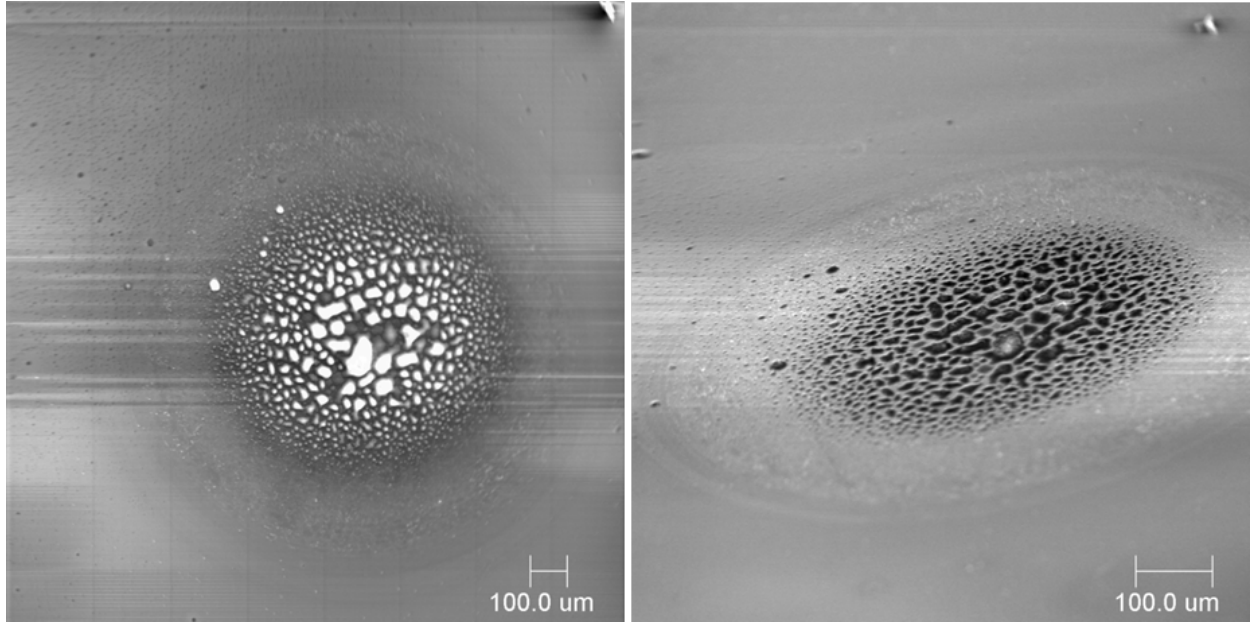
FIG. 6: SEM micrographs of the central damage area at different substrate inclination angles.

SEM micrographs of the central damage area are shown in Fig.(6). According to previously reported work on GaAs and GaAsP we believe that the central damage area has been caused, at least in part, by the back-bombardment of residual gas ionized by the beam [7, 8]. The ions in question are likely created between the photocathode and the entrance to the first SRF cavity, and upon entering the gun's accelerating field, can impact the surface with up to 250 keV of energy.

Furthermore, given that the central damage is predominantly at the electrostatic center, it is likely that the majority of the ions are produced once the beam has been aligned on its symmetry axis, which is done with corrector magnets after the exit of the gun. It is of interest to note that both the height and size of the microstructures increase as you approach the electrostatic center of the sample. This distribution of microstructures should be due to some nontrivial combination of the ion beam transverse profile with the integrated ion dose.

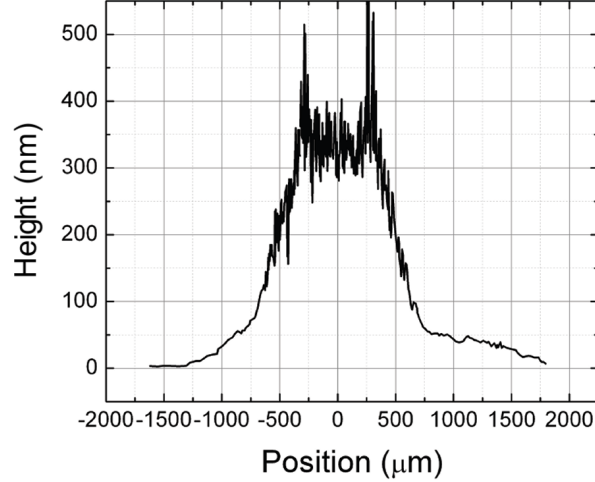
The surface profile from contact profilometry is shown in Fig.(7). While intuition suggested that the central damage area was a crater due to ion sputtering of material, the surface profilometry suggests that the damage site is raised (or simply roughened) with respect to the ordered substrate crystal. It is likely that the thickness of the tip obscures the

FIG. 7: Surface profilometry of the central damage area, indicates the presence of significant surface roughening. Due to the large tip size, the profile data should be interpreted as sampling the local maxima of the surface profile.

fast oscillations of the surface roughening, and thus the average height of 350 nm should be interpreted as an average of surface maxima.

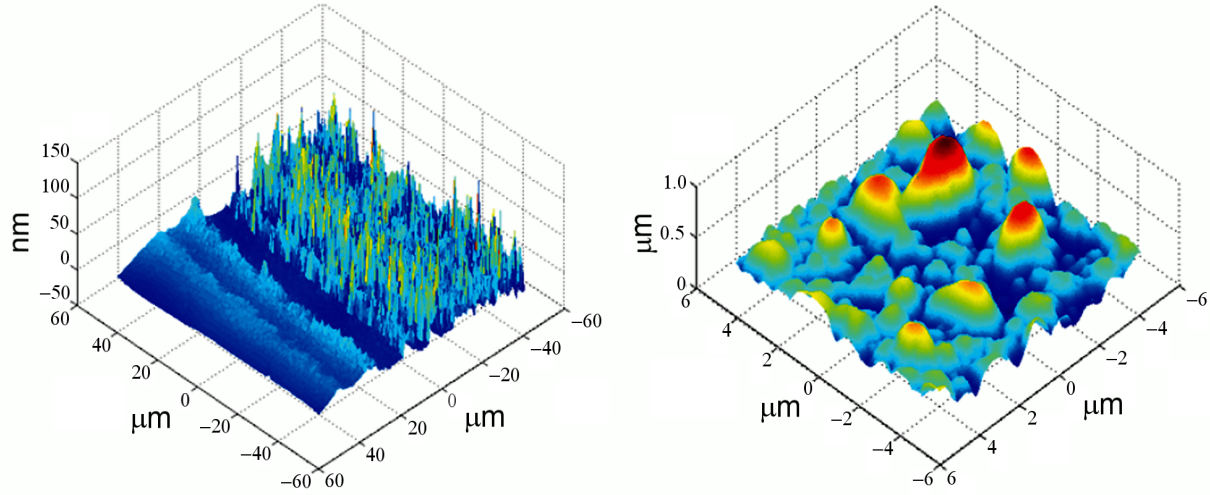
Atomic force microscopy was carried out over an area of  $100 \times 100 \mu\text{m}^2$  near the edge of the central damage, see Fig.(8, left). In these images the fast oscillations of the surface roughening are apparent. Moving from the border to the central part of the damage, the surface becomes more and more rough, but the resolution of this scan was unable to reveal details of the surface in the central part of the damage. Thus, we also performed surface scans with a smaller resolution over an area of  $10 \times 10 \mu\text{m}^2$  in an intermediate position between the edge and center of the central damage site, shown in Fig.(8, right). From this scan, we see that the surface exhibits no sharp point-like peaks, and has an rms surface roughness of about 100 nm.

FIG. 8: Atomic force micrographs of the central damage area. Left:  $100 \times 100 \mu\text{m}^2$  scan at the interface of the brownish area and the central damage site. Right:  $10 \times 10 \mu\text{m}^2$  scan at the mean distance between the center and edge of the central damage site.

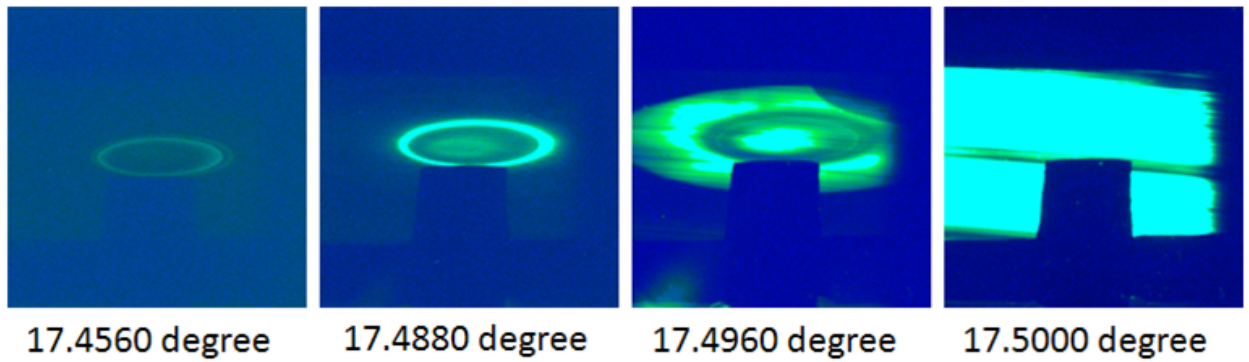
FIG. 9: False color photographs from the XRD CCD camera at various diffraction angles, illustrating the variation in lattice spacing as a function of distance from the central damage spot.

Fig.(9) shows a false color image taken with the XRD CCD at various substrate inclination angles, indicating a nearly radial distribution of lattice spacing, measured from the center of

the damage site. As the diffraction angle,  $\theta$ , approaches that of the Si(004) diffraction peak (see  $\theta = 17.4960^\circ$ ), a round area with well defined edges emerges in the upper right corner of the image, which was the location of the bi-alkali film, indicating lattice damage overlaps with the active area of the cathode. A rectangular lead stripe of thickness 2.1 mm was overlaid on the sample for length calibration; Fig.(10) reports the approximate diameters for the different areas of diffraction peaks.

The smallest diffraction angle corresponds to the region of largest atomic spacing. The annular region that first diffracts (at left in Fig. 9) appears to be the region of largest damage. It appears unlikely from a beam dynamics perspective that the backstreaming ion distribution should be annular (see section below). Thus, the surface region inside the

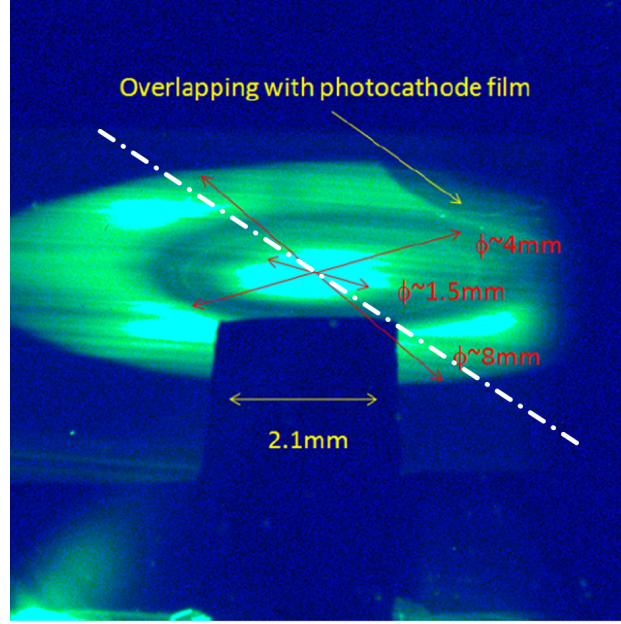
FIG. 10: Various diameters of the regions of interest from the XRD CCD snapshots. The white dotted line is the diameter over which data was sampled for Fig. (11).

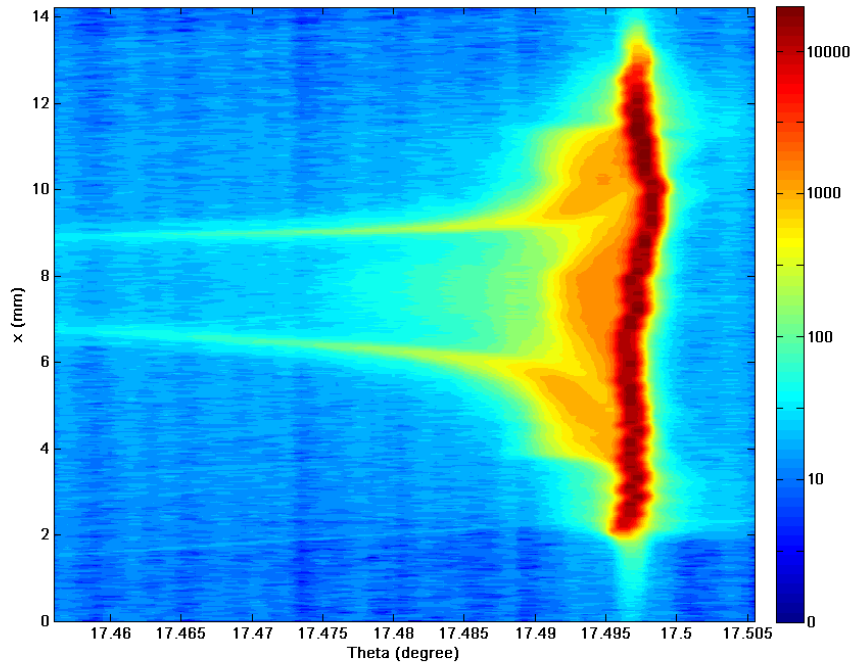
Given that the distribution of crystal strain regions is radial, we can collapse the spatial data down to one dimension, and plot the number of counts on the CCD detector as a function of both position along the diameter of the damage region and diffraction angle. This is shown in Fig.(11). The induced crystal strain is proportional to the deviation of the diffraction angle from the Si(004) peak (rightmost red region). The crystal strain is symmetric about the damage site center, and is sharply peaked on either side of the electrostatic center (here at  $x \sim 8$  mm).

FIG. 11: Counts on the CCD detector as a function of the position along a diameter of the circular damage region ( $x$ , vertical axis) and the diffraction angle.

annulus may be the site of complete amorphization of the surface, and thus not subject to diffraction. This region (as well as the region beyond the initial annulus) does begin to diffract at slightly larger angles, which may be due to the penetration of the x-rays below the amorphous layer, to a layer beneath which is strained but still crystalline. This is supported by the fact that at the Si(004) diffraction peak, the entire substrate including damage center diffracts, which may be due to the bulk, undamaged structure beneath (on the scale of  $\mu\text{m}$ ) the damaged surface. Given that the extinction depth of the incident x-rays is on the order of  $10\ \mu\text{m}$  (which also depends of atomic spacing), it is important to note that the diffraction vs. depth is unavailable from these scans.

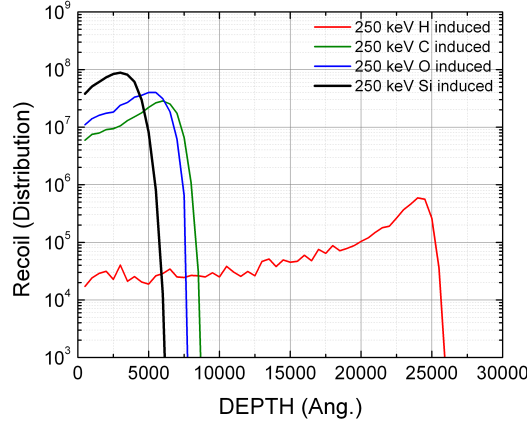
The results of the TRIM simulations were performed in *Surface Sputtering and Monolayer Collision* mode, and are shown in Fig.(12). It shows the number of atomic recoils for each species as a function of the ion penetration. It is clear from the TRIM data that the effect of hydrogen ions on the surface film is likely to be very small in comparison to that of carbon or

FIG. 12: The number of atomic recoils as a function of penetration depth for a variety of implanted ions.

oxygen, given both the small number of recoils and the relatively large penetration depth. Also, we conclude that we are well justified in applying results from Si self implantation literature, as the integrated number of atomic recoils of both carbon, oxygen, and hydrogen are comparable to that of Si. TRIM also reports the sputtering yield from the various implantation species; hydrogen was found to have a negligible sputtering yield, whereas carbon and oxygen ions at 250 keV have 0.16 and 0.18 sputtering yield, respectively, which alone appear to be inadequate to describe the features of the damage area.

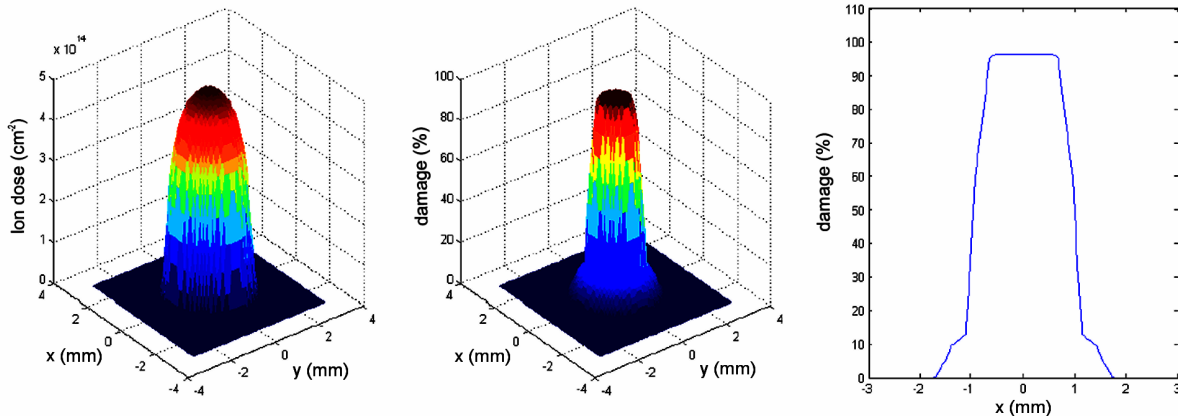
Using this information, a threshold dosage of  $4 \times 10^{14}$  ions/cm<sup>2</sup>, and the same damage vs. dose slope as in [12], we calculate the damage profile shown in Fig.(13, middle, right). The sharp increase in the damage is due to the superlinear response of the amorphization. We should note that in order to reach the onset of the superlinear damage, we used a number of ions only 10 times larger than the lower bound estimate, according to the rationale above. Upon inspection of the XRD data in Fig.(11), the sharp decrease in the number of counts for large angular offsets from the Si(004) peak near the center of the damage site may be due to

FIG. 13: Left: The 2D dose distribution of ions, calculated from the simulated electron beam profile at the DC gun anode. Middle: The damage profile, or percent amorphization of the Si using the ion beam profile and a superlinear model. Right: a cross section of the damage profile.

beam profile, along with the partial pressure and ionization cross section, yields the 2D ion dose distribution, which is plotted in Fig.(13, left).

the complete amorphization of the Si substrate surface, thereby suppressing the diffraction in that region, due to the onset of the superlinear damage regime. Thus, there is good qualitative agreement between the ion back-bombardment calculated damage profile and both the profilometric and XRD maps.

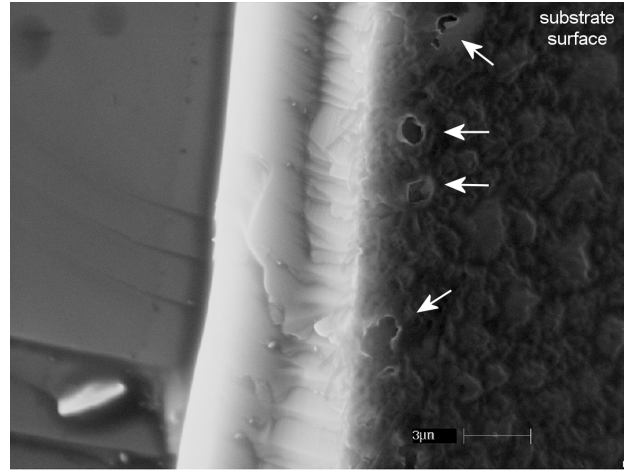
In order to investigate possible means of the formation of the surface roughening/protrusions, the sample was hand-cleaved through the center of the damage area, and a high-resolution SEM micrograph was taken of the substrate cross section near the surface. These micrographs are shown in Fig. (14) and Fig. (15). Fig. (14) indicates the presence of pore structures below the Si substrate. Similar pore production has been reported in literature as a consequence of ion implantation with doses several orders of magnitude larger than the ones we calculate incident upon our photocathode [13], which suggests that our estimate of the total ion dose may be far lower than the actual value. Furthermore, Fig. (15) indicates the presence of bubble-like regions 10's of  $\mu\text{m}$  deep (deeper than the expected penetration of 250 keV ions), which are present only below the damage region, and not below hand-cleaved pristine Si. The nature of these structures is still currently under

FIG. 14: SEM micrograph of the substrate cross section, beneath the damage site. The surface of the substrate is towards the right. Pore structures are indicated by arrows.

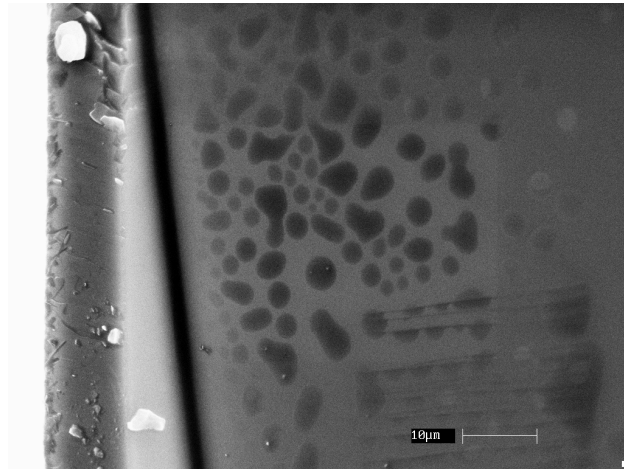
FIG. 15: A lower resolution, larger scan range SEM micrograph beneath the damage site. The surface of the substrate is towards the right.
